Nor848A Acoustic camera

Identifying Short Time High Pitch Squeak Noise from Electric Window in Car Door

Jørgen Grythe, Norsonic AS

Measurements in car factory Korea, July 2015

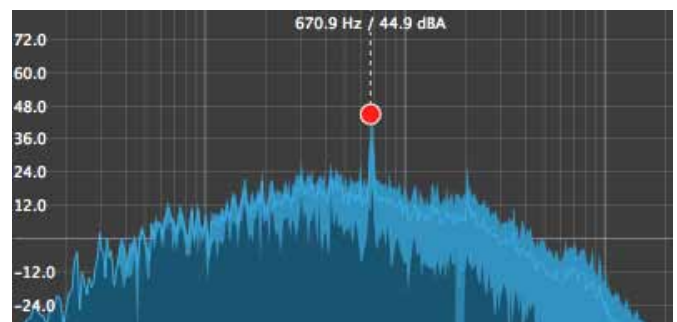
In addition to the high pitch squeak noise, sound from the electric engine could also be heard which was around 670 Hz as seen below. Since this sound was present during the entire recording, it could be easy to misinterpret the

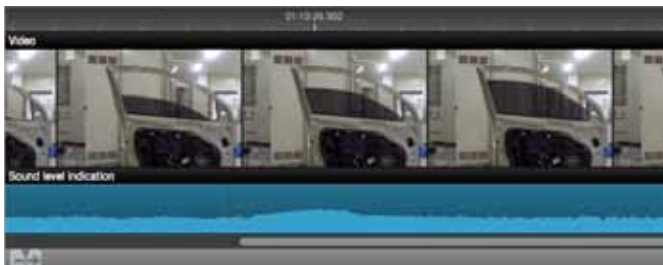
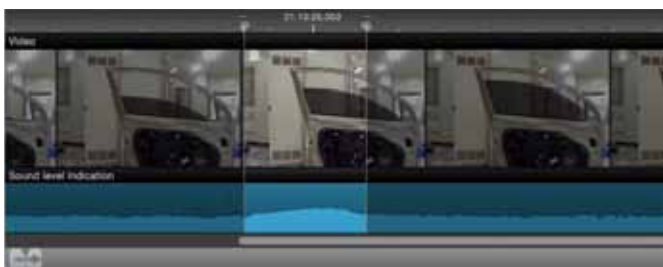
As opposed to the stationary sound from the electric engine, the high pitch squeak noise was only happening for a brief period of time, around 300 ms. By defining a scene in the sound level indicator pane of the acoustic camera software, it was then possible to analyse events happening only within the time frame of the extent of the scene. The scene is made by simply dragging the cursor over the region of interest in the software as seen below.

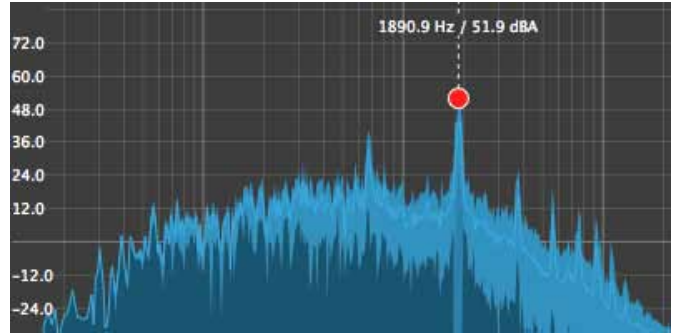
Now by calculating the average spectral density over that part of the recording, it was easy to see that in addition to the noise from the electric motor around 670 Hz, a high pitch tonal noise with a fundamental frequency around 1890 Hz could also be seen in the frequency spectrum. In addition harmonics of the fundamental frequency up to the 7th harmonic was visible in the spectrum.

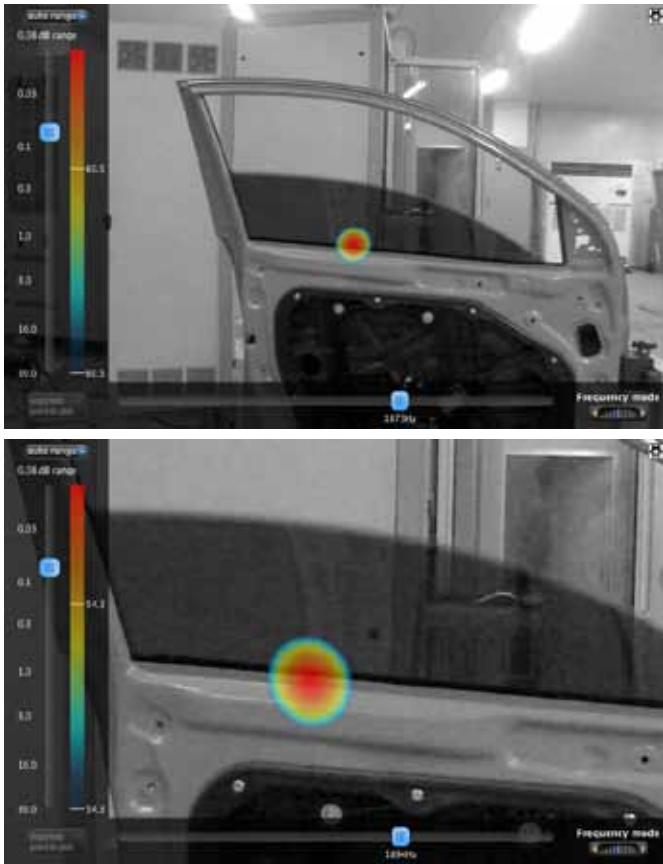
Lastly, due to the tonal nature of the noise it was possible to switch from the ordinary, robust wideband algorithm, to the adaptive algorithm for narrowband applications.

This further helped in pinpointing the exact location of the problem. Higher resolution could also be achieved by zooming further in in the image.
